NASA SP-6

SECOND UNITED STATES
MANNED ORBITAL SPACE FLIGHT

PROJECT MERCURY

RESULTS OF THE SECOND U.S. MANNED ORBITAL SPACE FLIGHT MAY 24, 1962

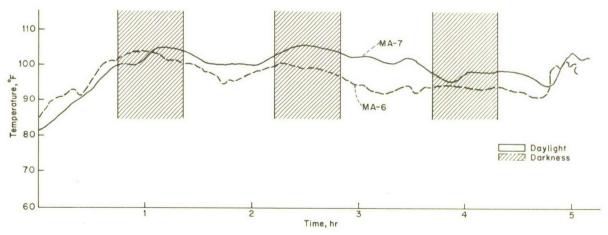
FIGURE 1-10.—Cabin-air temperatures.

are plotted in figures 1-10 and 1-11, respectively. In the same figures, the cabin and suit temperatures measured during the MA-6 mission are shown for comparison. The high temperatures were the only anomalies evident in the ECS during the flight.

The high cabin temperature is attributed to

a number of factors, such as the difficulty of achieving high air-flow rates and good circulation of air in the cabin and vulnerability of the heat exchanger to freezing-blockage when high rates of water flow are used. Tests are currently being made to determine if the cabin temperature can be lowered significantly without requiring substantial redesign of the cabin-cooling system.

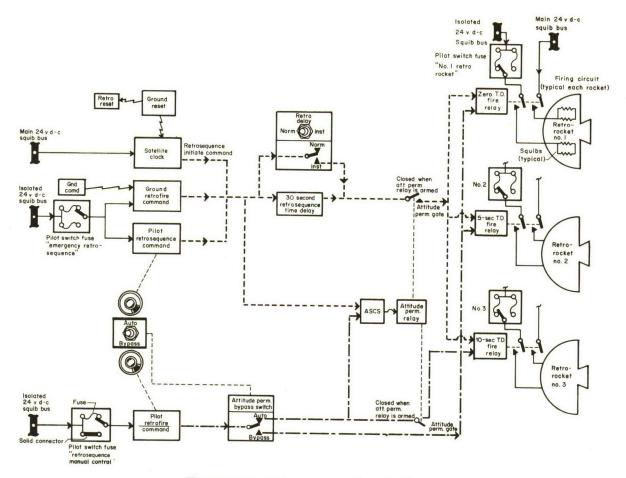
FIGURE 1-12.—Retrosequence schematic diagram.

As expected, squib-circuit fuses were found to be blown, including the number 1 retrorocket switch fuse which also had a small hole on the side of the ceramic housing. Postflight testing demonstrated that at the electric current levels experienced in flight, the casing of these fuses could be ruptured and significant quantities of smoke could be produced. It was confirmed by the astronaut during postflight tests, where he observed two similar fuses being blown, that these fuses produce a smoke having the same color and odor as that encountered in flight at the time of retrofire.

quential circuitry performance was according to design. After waiting for about 2 seconds, Astronaut Carpenter actuated the manual retrofire switch. He reported that an additional delay of about 1 second occurred before the retrorockets actually ignited, which normally would take place instantaneously. No explanation is available for this additional 1-second delay, since exhaustive postflight testing has failed to reveal any trouble source in the ignition sequence circuitry.

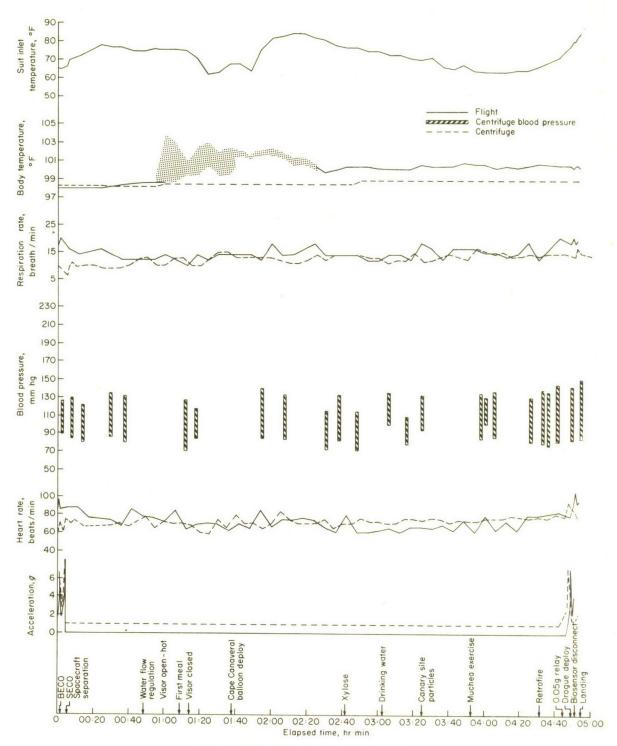
FIGURE 5-5.—Bioinstrumentation in flight.

The instability of the body temperature readout is believed to have been the result of erratic behavior of the amplifier from 59 minutes to 2½ hours after launch, approximately one-third of the flight. This erratic period is shown as a shaded area in figure 5–5. The values at all other times are considered valid.

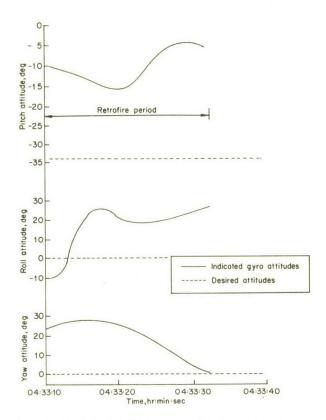
FIGURE 6-4.—Indicated spacecraft attitudes during retrofire. Not corrected, gyros free.

Figure 6-4 presents the gyro output attitude indications as well as the desired attitudes to be held during retrofire. Because of the horizon scanner malfunction, the gyro indications do

not necessarily represent the true spacecraft attitudes particularly; however, they do illustrate the trends in attitude as a function of elapsed time during retrofire. However, these are the indicated attitudes displayed to the pilot.
